Manhole Inspection Summary

Manhole # S25E__009MH

Insp Date: **8/9/07 7:50 AM**

Location Address: **1207 LEXINGTON ST**

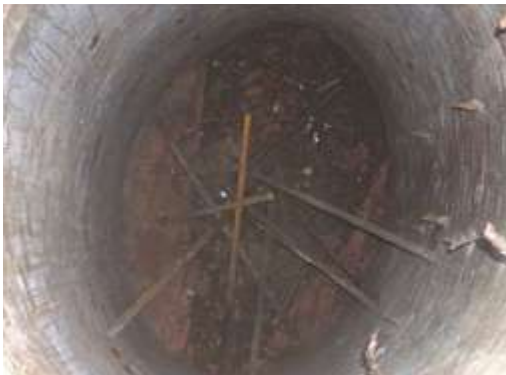
Defect 3

Condition: ☐ Sound ☐ Cracked ☐ Root Intrusion ☐ Deteriorated ☐ Leaks ☒ **Debris**

DEBRIS

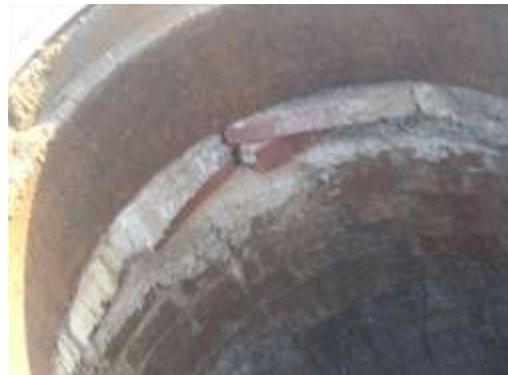
Defect 2

Condition: ☐ Sound ☐ Cracked ☐ Root Intrusion ☒ **Loose Brick** ☐ Deteriorated

Infiltration: ☐ None ☒ **Joint** ☐ Cracks ☐ Mortar ☐ Roots ☐ Wall

LOOSE CHIMNEY BRICKS AND
INFILTRATION

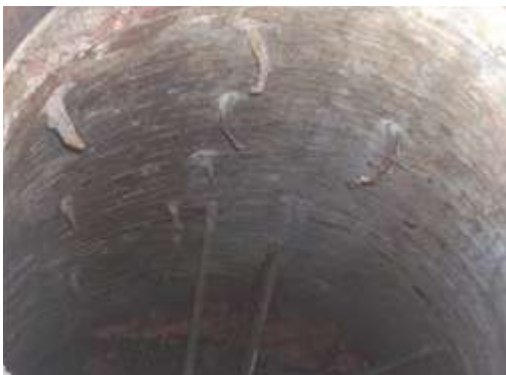
Defect 1

Count: **0** Missing: **4** ☐ Corroded

NO STEPS ALL MISSING

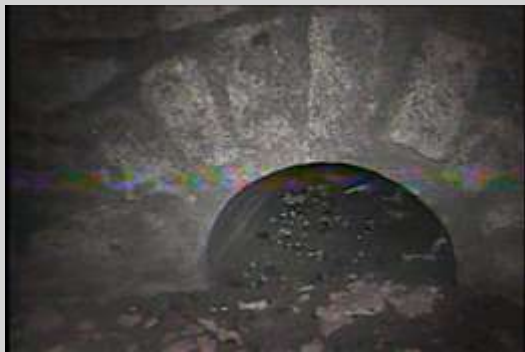
12 O'Clock Outflow

8 in. Circular Gravity Sewer
Pipe Out @ 12 O'Clock

Deposits: ☐ None ☐ Mud ☐ Sludge ☒ **Debris** ☐ Grease

Silt Depth: **1** (in.) Deposits Extent: **Light**
